Government Accountability Office (GAO)
Headquarters Building

PROJECT SUMMARY

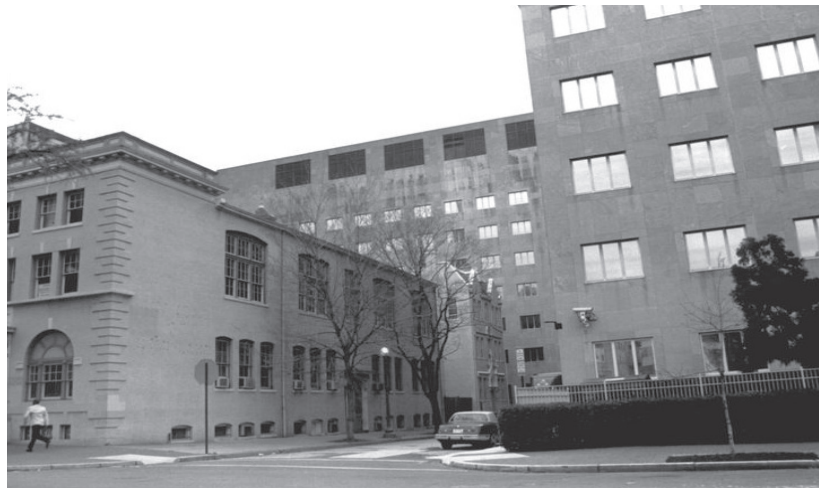
As in many postwar buildings, the mechanical room and all its components were constructed as part of the building structure. The massive 14'+ height air handlers reached EOL (End-of-Life) and required replacements.

Due to existing piping and ductwork space limitations around the units, extensive coordination was required.
